Inspection Report
Minerals Regulatory Program
Report Date October 14, 2005

Mine Name: Neal State
Operator Name: Ziegler Chemical

Permit number: S/047/063
Inspection Date: September 1,
2005
Time: 4:00-4:20 PM

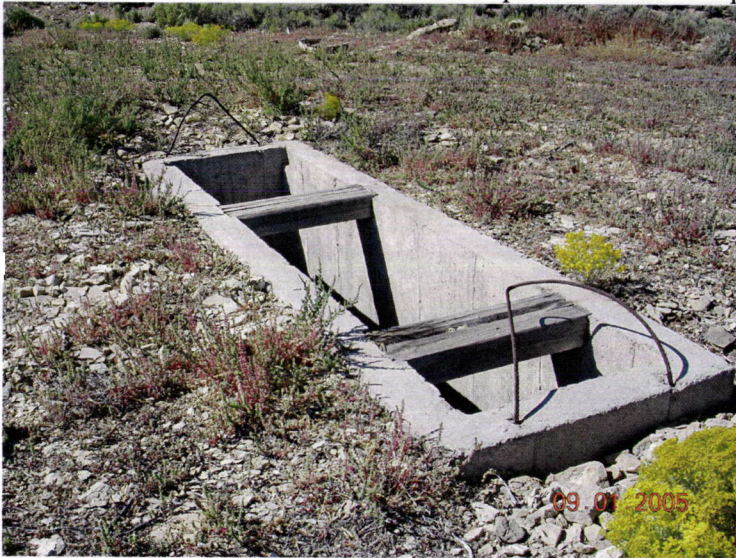
Photo 1.

The main part of the site contains a derrick and a shaft where a concrete collar has been poured (Photo 1). Across a small drainage from this pad, the operator has excavated a portion of the Gilsonite vein (Photo 2). It looked like some of the excavated material had been placed back in the vein nearest the drainage or that it was not dug out as deeply (Photo 3). In other areas, one could look down about ten feet or more into the vein and see some of the workings. It was difficult to photograph the inside of the vein, but looking closely at Photo 4, some of the workings and what I presume to be support structures are visible.

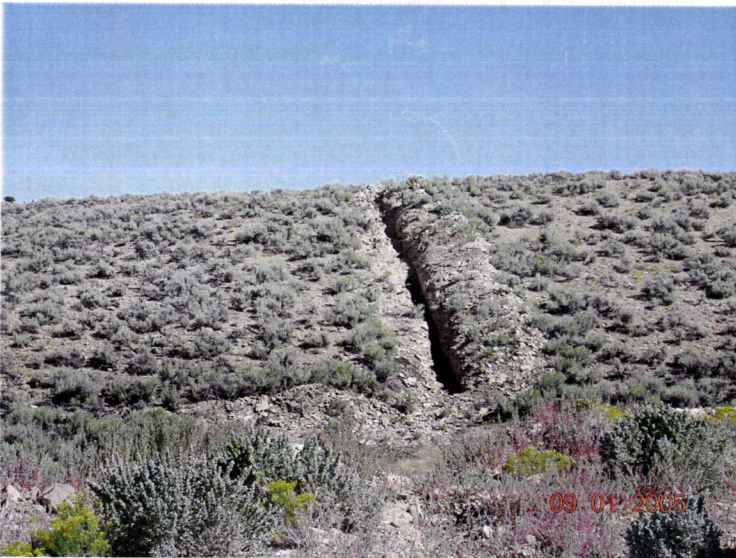
Photo 2. This shows the exposed Gilsonite vein.

I consider the excavated Gilsonite vein to be dangerous, and it needs to be backfilled or otherwise secured, such as by fencing.

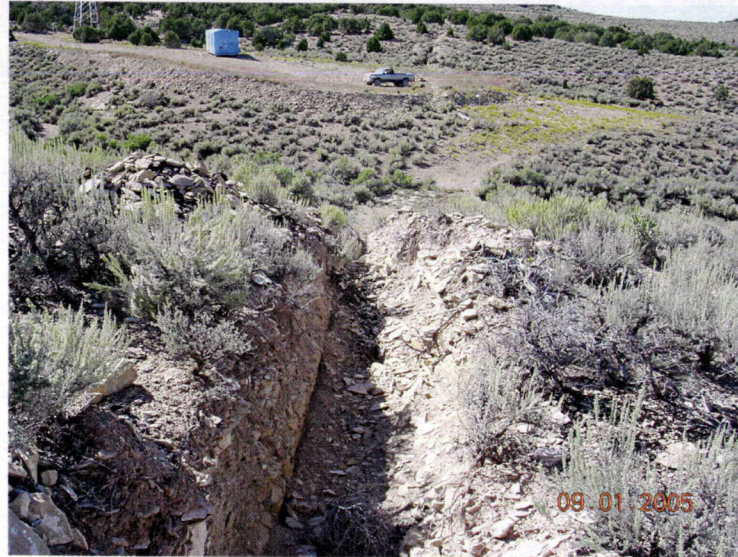
Photo 3. The lower part of the exposed vein.

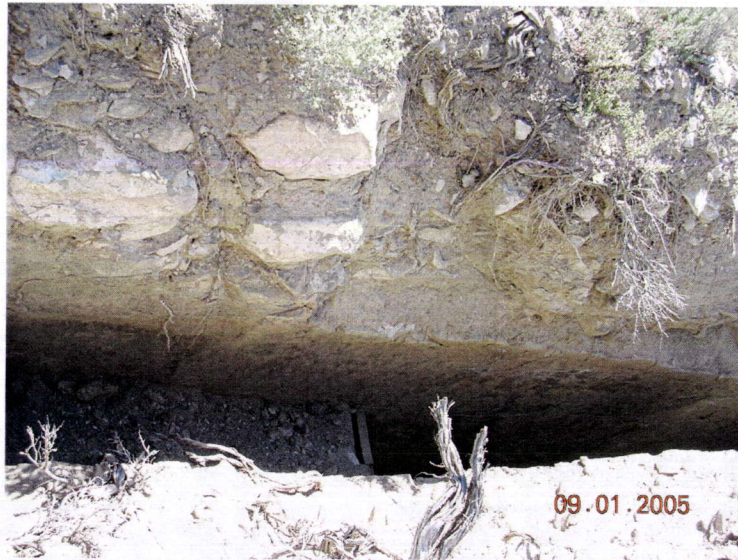
Photo 4. Looking closely, one can see wooden structures in the vein.
